UH-1N INSTRUMENT FLIGHT, TURBULENCE, AND ICING TESTS

TECHNICAL REPORT No. 71-9

MARCH 1971

**AIR FORCE FLIGHT TEST CENTER
EDWARDS AIR FORCE BASE, CALIFORNIA
AIR FORCE SYSTEMS COMMAND
UNITED STATES AIR FORCE**

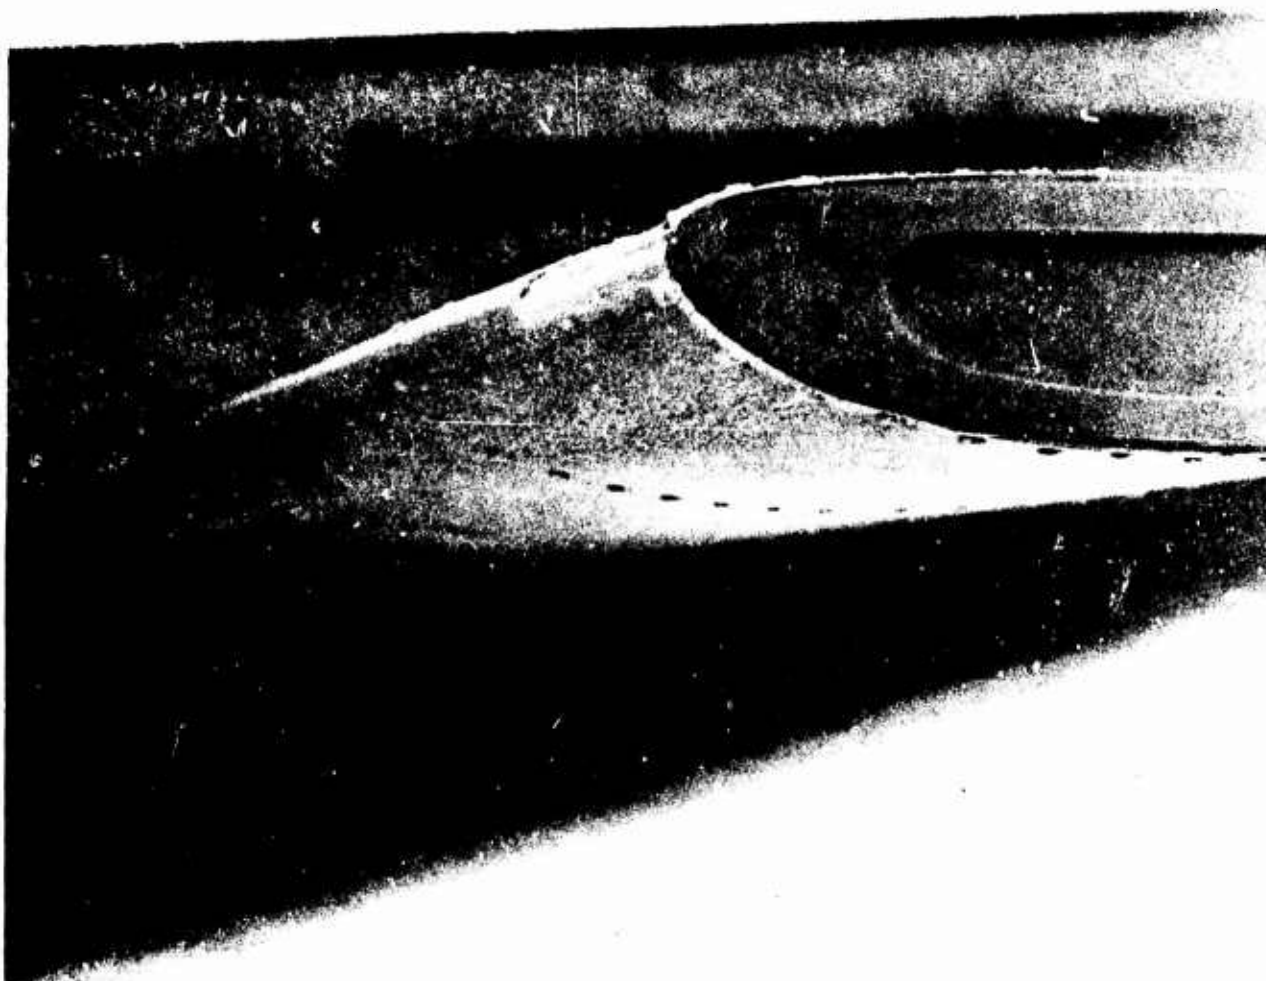
Ice accumulation thickness on the synchronized elevators (figure 5) and tail rotor section was minimal (1/8-inch maximum) for all icing conditions (trace, light, moderate) tested. The tail rotor section accumulated about one-half as much ice as the nose and rotor hub areas for all test points. The helicopter aft section accrued less ice due to engine exhaust venting. Ice accrued up to 1/4-inch thick on the nose, windshield, rotor hub (figures 6 and 7) and engine inlet lips (figure 8) during test points 7 and 8 (table IV). No structural damage occurred during any of the icing tests conducted.

Figure 5 Clear Ice (1/8-inch Thick) on Synchronized Elevator (Test Point 8)
